EVALUATION OF ARMCO PH13-8Mo

Jack M. Uchida  
Boeing Company  
Renton, Washington

19 November 1969

DOCUMENT NO.	D6-23927
TITLE:	EVALUATION OF ARMCO PH13-8Mo
MODEL	RESEARCH

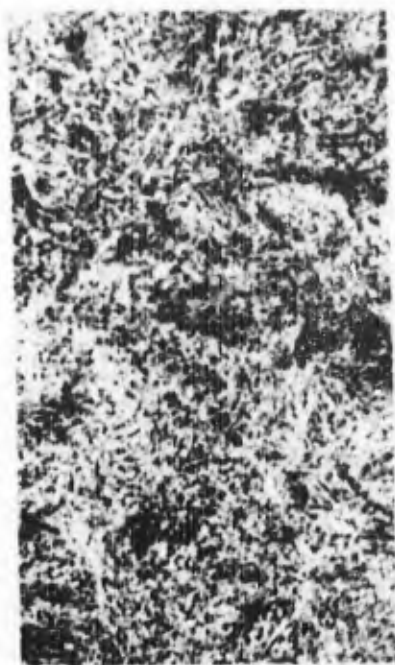
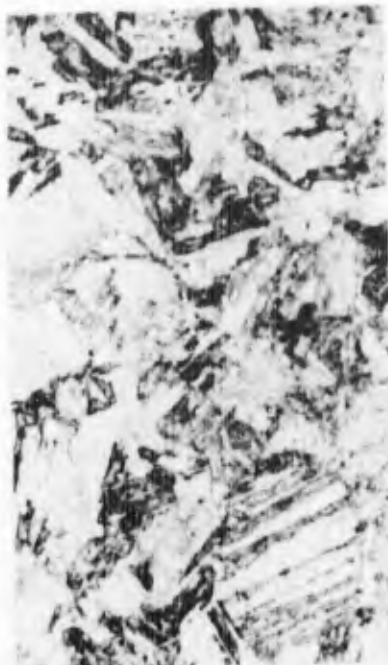
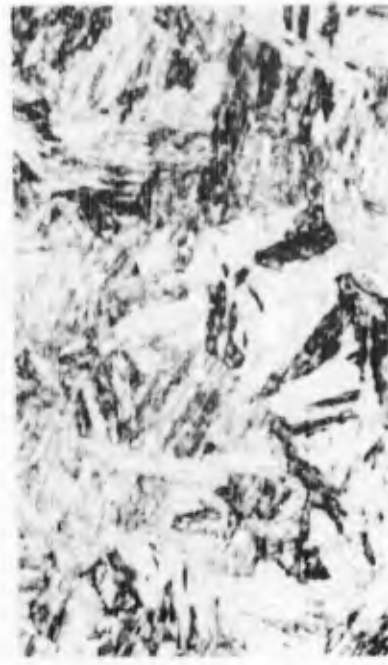
FIGURE 2

SOLUTIONED AT 1600°F  
AGED 3 HRS AT 950°F  
MAGNIFICATION 500X  
FRY'S ETCH

SOLUTIONED AT 1700°F  
AGED 3 HRS AT 950°F  
MAGNIFICATION 500X  
FRY'S ETCH

SOLUTIONED AT 1800°F  
AGED 3 HRS AT 950°F  
MAGNIFICATION 500X  
FRY'S ETCH

EFFECT OF SOLUTION TREAT TEMPERATURE  
ON THE MICROSTRUCTURE

The effects of solution and aging temperatures were investigated to confirm the vendor's data and to determine the temperature limits which could be tolerated. Solution temperatures at 1600°F, 1700°F, and 1800°F were investigated and the effects on the microstructures are presented in Figure 2. Aging temperatures from 700°F to 1700°F were used to study the effects of temperature on hardness and microstructure, and the results are presented in Figures 3 and 4.

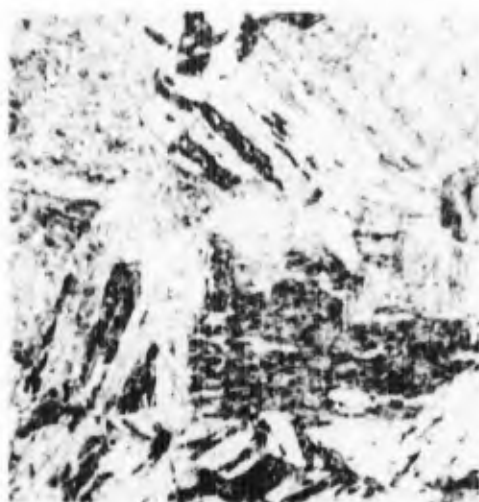
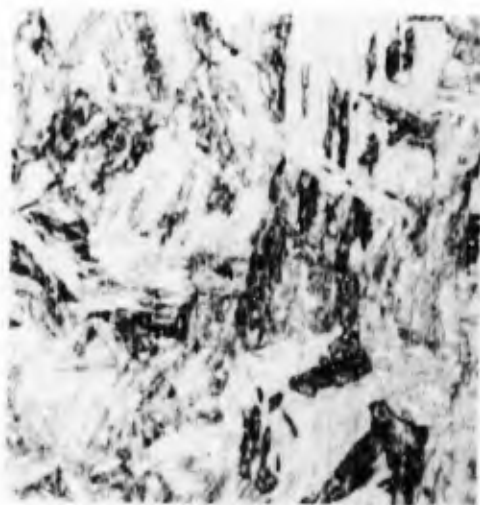
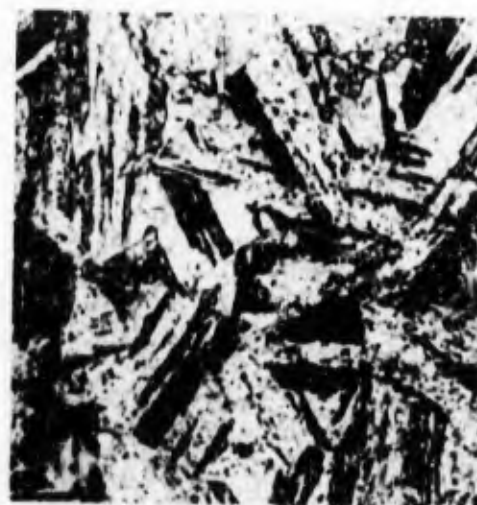
3 HRS @ 700°F RC 37

3 HRS @ 800°F RC 42

3 HRS @ 850°F RC 46

3 HRS @ 900°F RC 46.5

3 HRS @ 950°F RC 46

3 HRS @ 1000°F RC 46

FIGURE 3  
AGING STUDY  
SOLUTIONED AT 1700°F; AGED AS INDICATED: MAG 500X; FRY'S ETCH

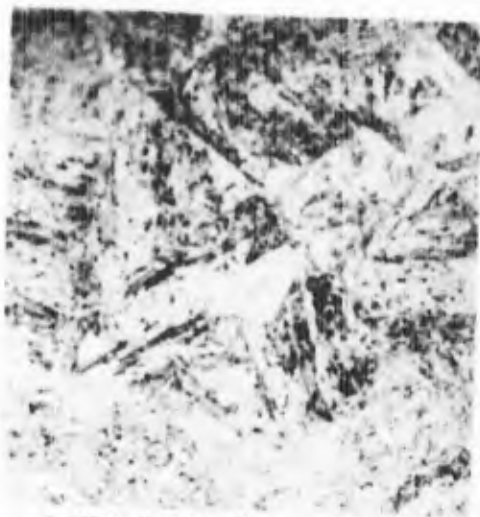
FIGURE 4

3 HRS @ 1050°F RC 43

3 HRS @ 1100°F RC 43

3 HRS @ 1200°F RC 33

3 HRS @ 1300°F RC 31

3 HRS @ 1400°F RC 32

3 HRS @ 1500°F RC 33.5

AGING STUDY

SOLUTIONED AT 1700°F, AGED AS INDICATED: MAG 500X; FRY'S ETCH
